Case Study in Exterior Storm Windows

Lyman House Weatherization Project: Exterior Storm Windows

A Component of Energy Retrofit project supported by Massachusetts Department of Energy Resources

Work completed August 2011-December 2011

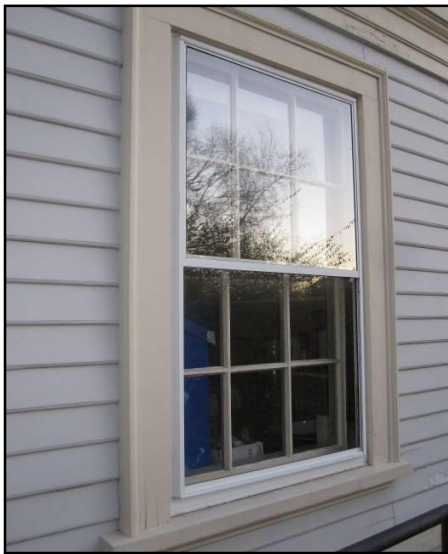
Exterior storm windows were extant on the west wing of the mansion house. The date of installation of these storm windows is unknown. The existing aluminum storm windows were white ðtriple track storm windows in varying degrees of functionality. In some cases, the screen and / or glass panels were missing. In other cases, the panels were no longer movable. Where screen and glass panels existed and were functional, there was no seasonal plan to appropriately set the panels.

Example of existing exterior storm window prior to 2011 work

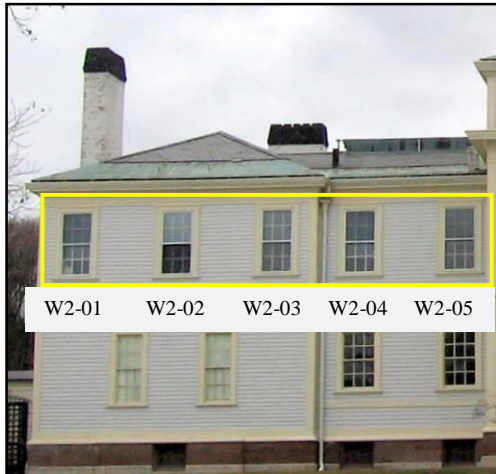
South elevation, 2nd floor office windows

Exterior Wooden Storm Window Treatment

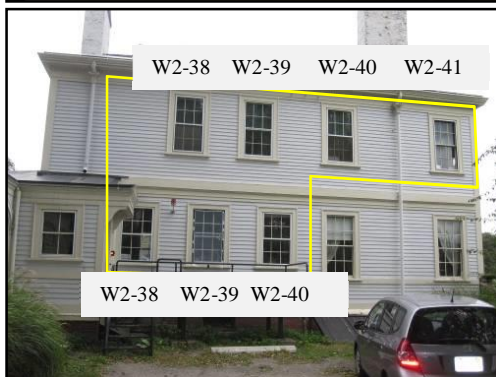
West elevation, 2nd floor office windows and 1st floor kitchen

Note that the three windows not highlighted did not have exterior storm windows and thus were treated with

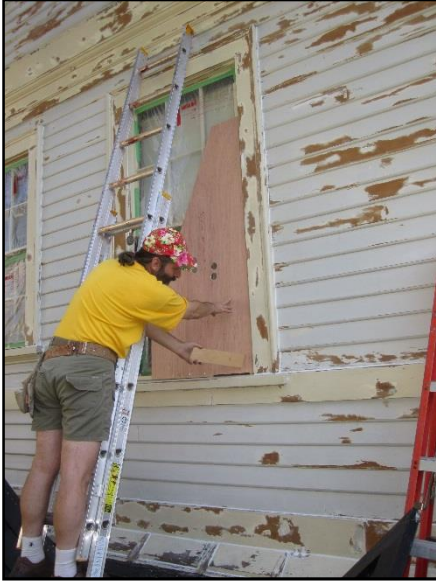
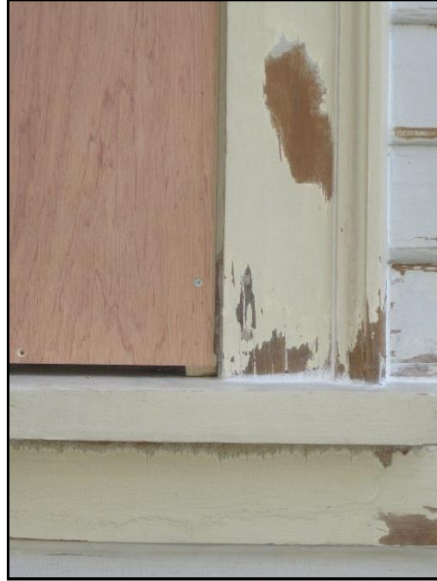
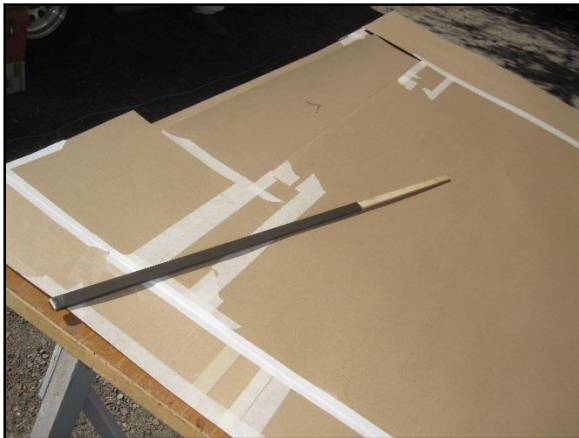
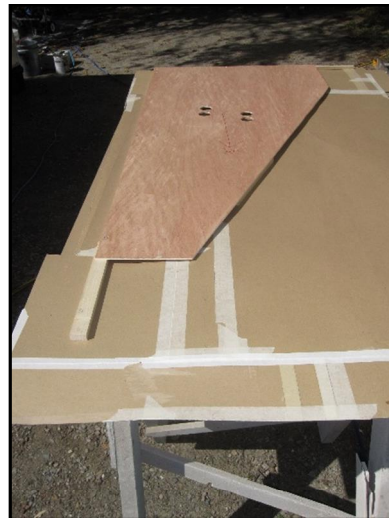
Template development for each opening

The wooden storm windows were custom made by Architectural Detail in Wood, based in Shirley, MA. After templating each opening for precise fit of the storm window, the windows were crafted from Honduran Mahogany using traditional pegged mortise and tenon joinery with a middle rail that aligns with the meeting rail of the double hung sash. Modern float glass of 1/8" thickness was used.

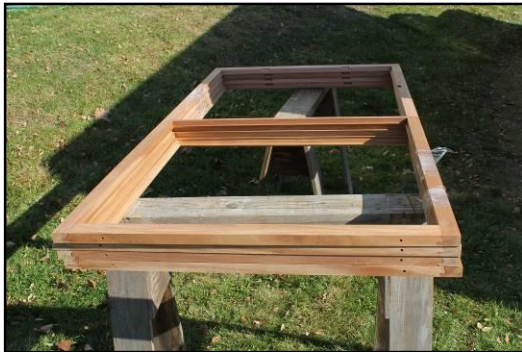
Storm window frames ready for dry fit to each opening

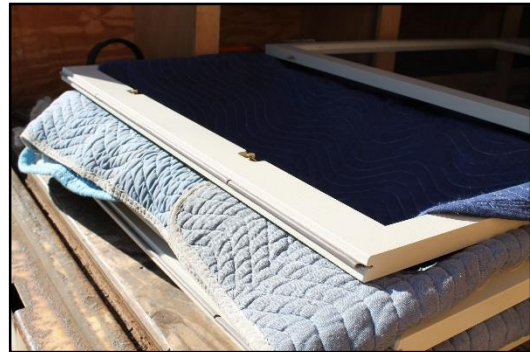
Silicone weather stripping

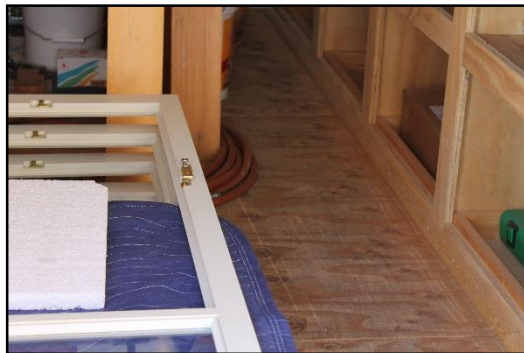
Brass hardware for securing lower light removable panel

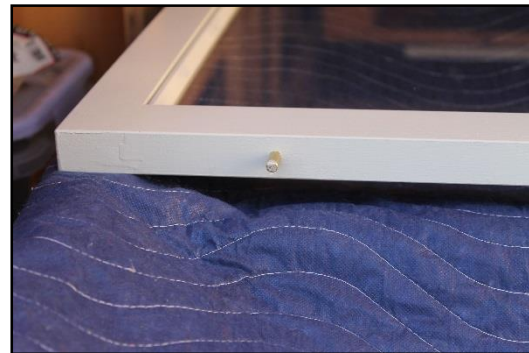
Brass pins to set in head casing

This wooden storm window fits flush in the window opening, seated against the blind stop. Two brass pins poke into the head casing and the window is held tightly to the blind stops with brass hardware installed from the inside. This installation differs from a more traditional wooden storm window installation where the window hangs over the face of the window opening. As there was no photographic evidence of such an exterior storm window for the Lyman House, there was no intent to install that type. As such these storm windows present a minimal visual impact when viewed from the outside.

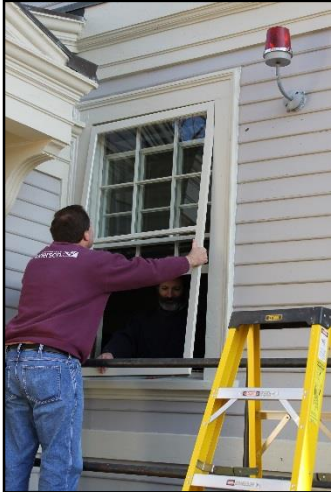
Installation

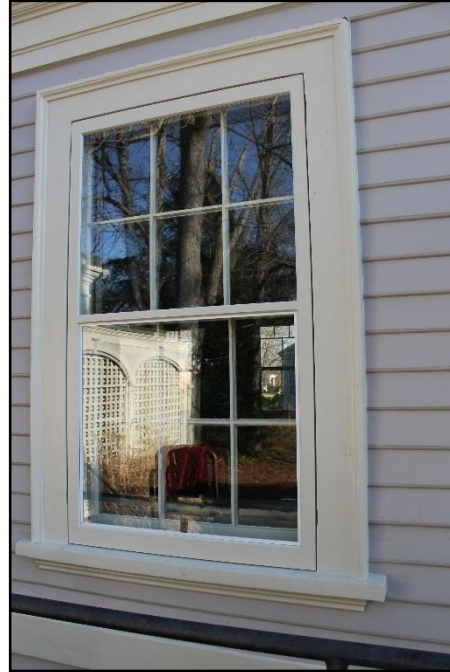
Completed installation

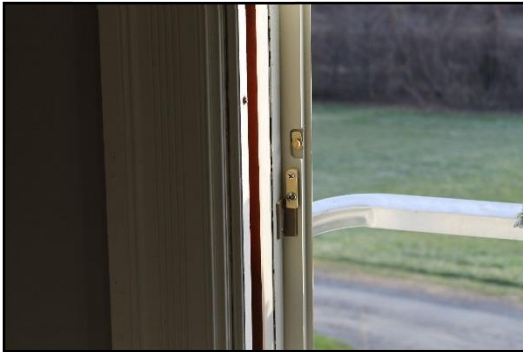
Hardware

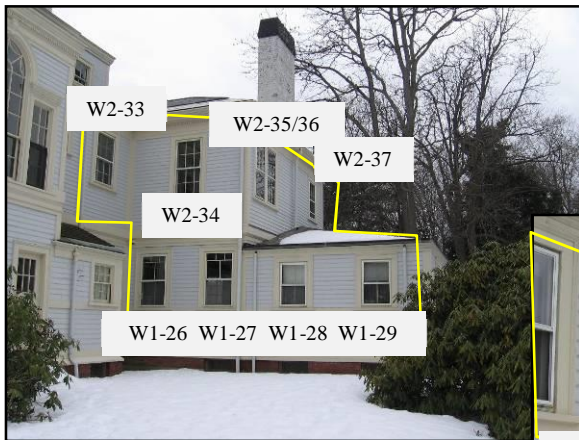
*North elevation, 2nd floor office windows
and 1st floor kitchen and service wing*

Exterior Aluminum Storm Window Treatment

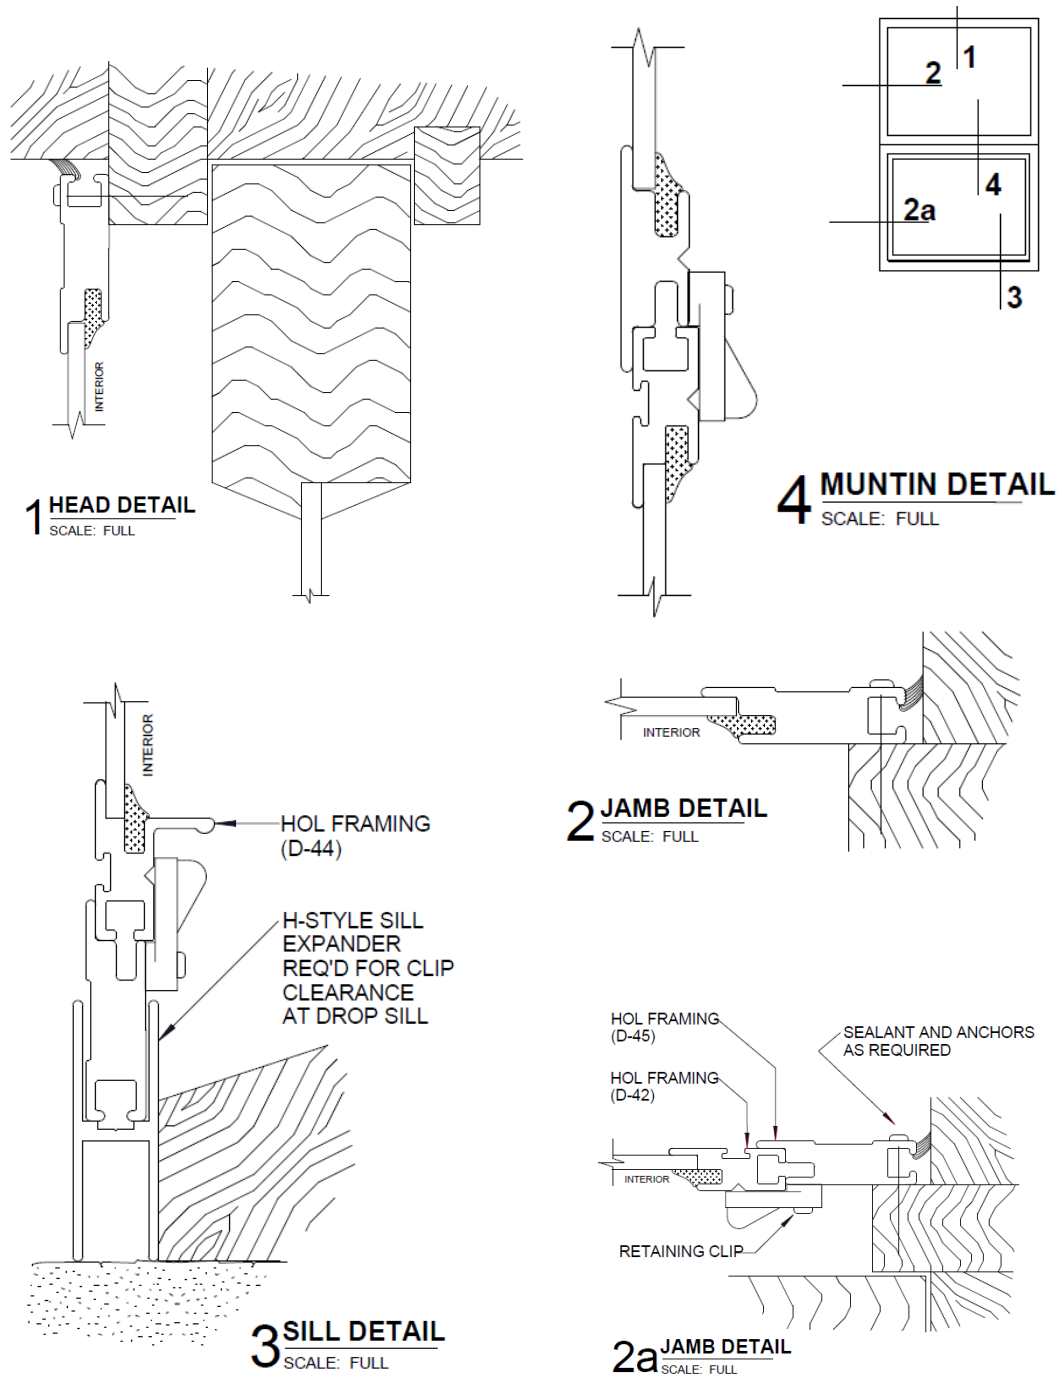
Drawing details of Allied HOL exterior storm window

The top is fixed and the bottom panel is removable to the interior. An interchangeable screen for this bottom panel was included in the purchase. The horizontal divider for the master frame of the (HOL) is aligned with the meeting rail on the existing window.

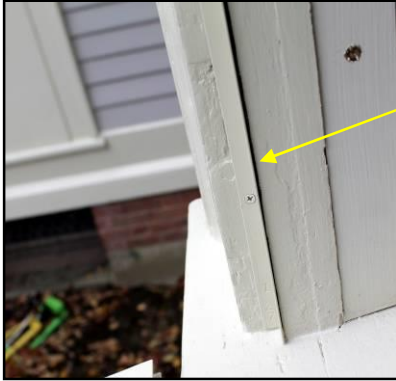
*L-bracket secured to window's blind stop
at both sides and top*

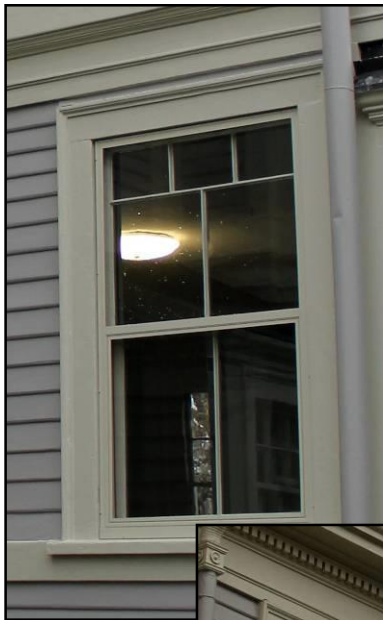
*Storm window is slipped into bottom
expander*

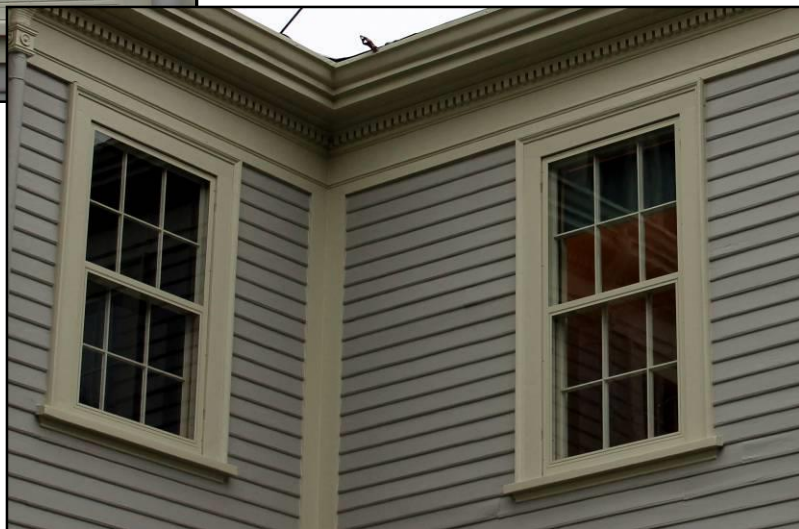
L-bracket is caulked

*Storm window is seated into bracket and
screwed to L-bracket*

Bottom expander is adjusted for fit against
