### **Case Study - Insulation**

Lyman House Weatherization Project: Insulation

*A Component of Energy Retrofit project supported by Massachusetts Department of Energy Resources*

Work completed April 2012

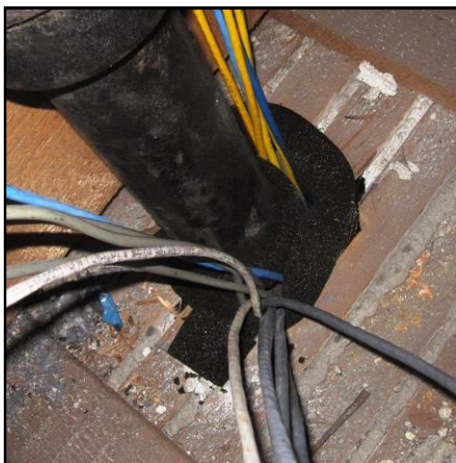
*CC Expanding Sealer expands into opening created for plumbing and data cables*

The use of a highly compressed porous foam (CC Expanding Sealer) was used to seal accessible gaps that were less than 10 in diameter. This foam has a light adhesive backing to hold in position over the 1-3 hour expansion time. The foam slowly expands to mold into the opening space, conforming to the irregularities of the opening.

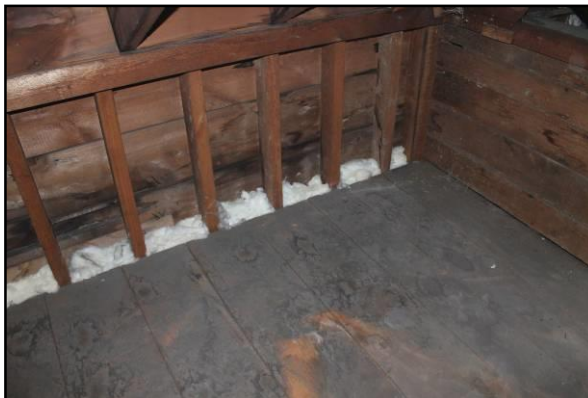
*Roxul insulation fit into joist bay openings above the ballroom*

Large voids (>10) between the second and third floor caused by electrical, plumbing, and data runs were reversibly sealed with the use of Roxul insulation. Roxul is a rock-based mineral fiber insulation comprised of basalt rock and recycled slag. It has advantages over fiberglass with its ability to be moisture resistant and vapor permeable. As such, if it does become wet, once dry it will regain its original performance characteristics whereas fiberglass will not.

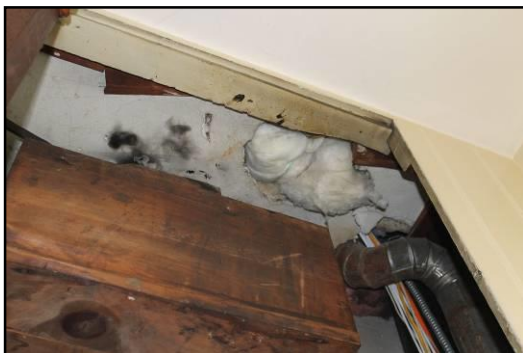
*Roxul insulation fit into opening created by previous plumbing pipes*

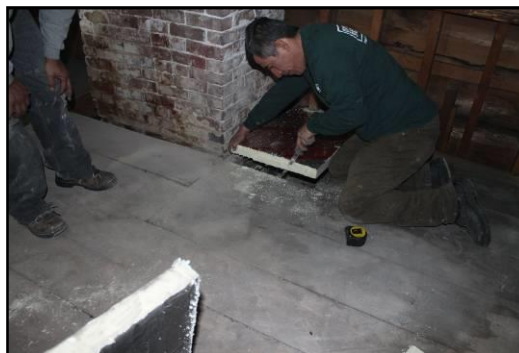
*2" foam board cut to fit around opening adjacent to chimney above the ballroom*

The voids adjacent to the chimney in the ballroom attic space were covered with foil backed foam board.

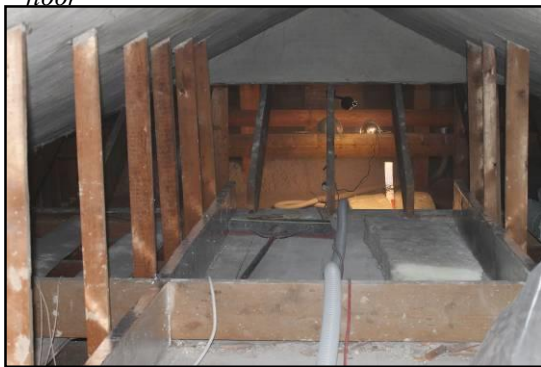
*Foam board "walls" in catwalk space to contain insulation*

There is a catwalk over the ballroom chamber with the ceiling joist bays exposed on both sides of the catwalk. As these bays were open, the bays were filled with cellulose insulation in a 'loose fill' manner. As such, the insulation was deeper in these cavities in order to provide for the desired R value. To contain the insulation, foam board walls were set along the sides of the catwalk to keep the insulation from covering the catwalk.

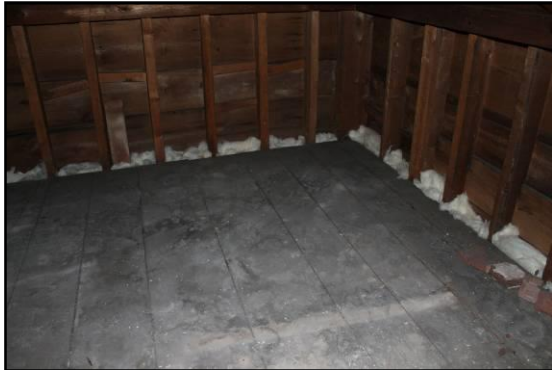
*Insulation sealing the gaps in the wall pocket*

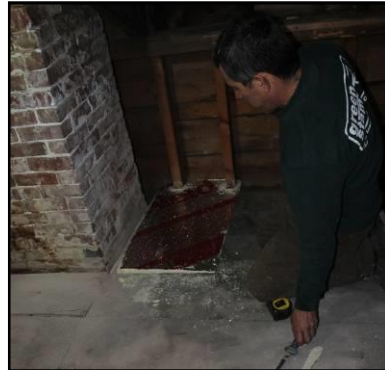
*Foam board sealing around chimney chases*

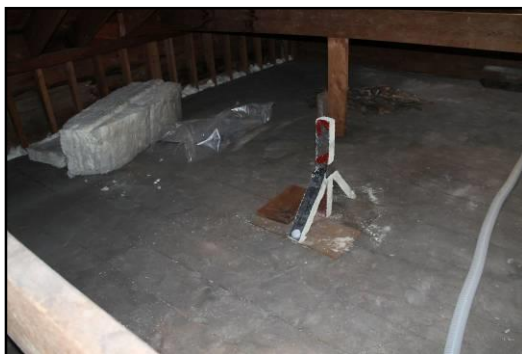
*Beacon to identify access hatch to ballroom ceiling*

Over the ballroom space, it was decided to blanket the ballroom attic floor rather than attempt to fill the void between the ballroom ceiling and attic floor. Accessibility and risk of potential damage in this space was the primary decision driver. As the construction of the ballroom evolved over time with newer exterior walls, there was a series of joist bays along the perimeter. These bays were blocked at the level of the attic floor with the Roxul insulation batts stuffed into the opening. Similarly, the chases alongside of the chimney ran the full height of the building from the basement. These chases were capped off with foam board. Once the floor was sealed at the perimeter, approximately 20' of loose fill cellulose insulation was blanketed on top of the floor. As this makes the ballroom attic floor inaccessible, a tower of foam board was set on top of a removable floor board section. If there is ever a need to access the space above the ballroom ceiling, this "beacon" provides identification of the access location and a path could be cleared to this opening.

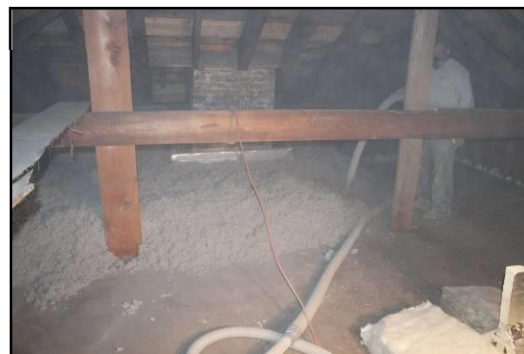
*Filling the ballroom attic with insulation*

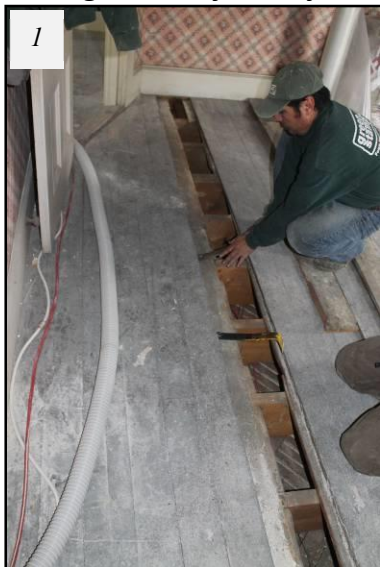
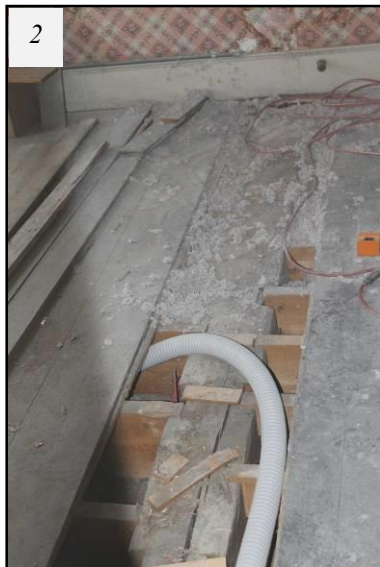
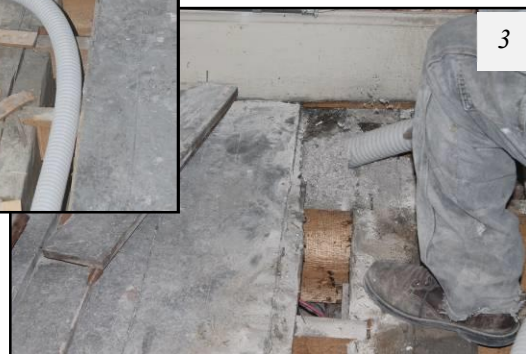
- 1 - Floorboard removal with the use of prybars and patience
- 2 - Hose delivery of cellulose insulation
- 3 - Removal of hose as joist pocket fills with insulation

For the rooms that faced to the rear and for the hallway, the top floor and sub floor were laid parallel to each other. This allowed for the need to remove 2-3 top floor and 1-2 sub floor boards across the length of a room in order to expose the joist bays. Floor boards were carefully removed with pry bars. There was minimal damage to the top floor in this fashion as the cut nails were gradually coaxed free from the subfloor below. It was determined that the joist bays in these locations ran the full length of the room with no obstructions other than occasional diagonal bracing. This detail allowed for the easy insertion of the insulation delivery hose to the edge of the room and thus the gradual blowing in of the cellulose as the hose was pulled out. This is the ideal situation for dense pack blown in cellulose as the product can be installed in the compact area for the full length of the joist bay.

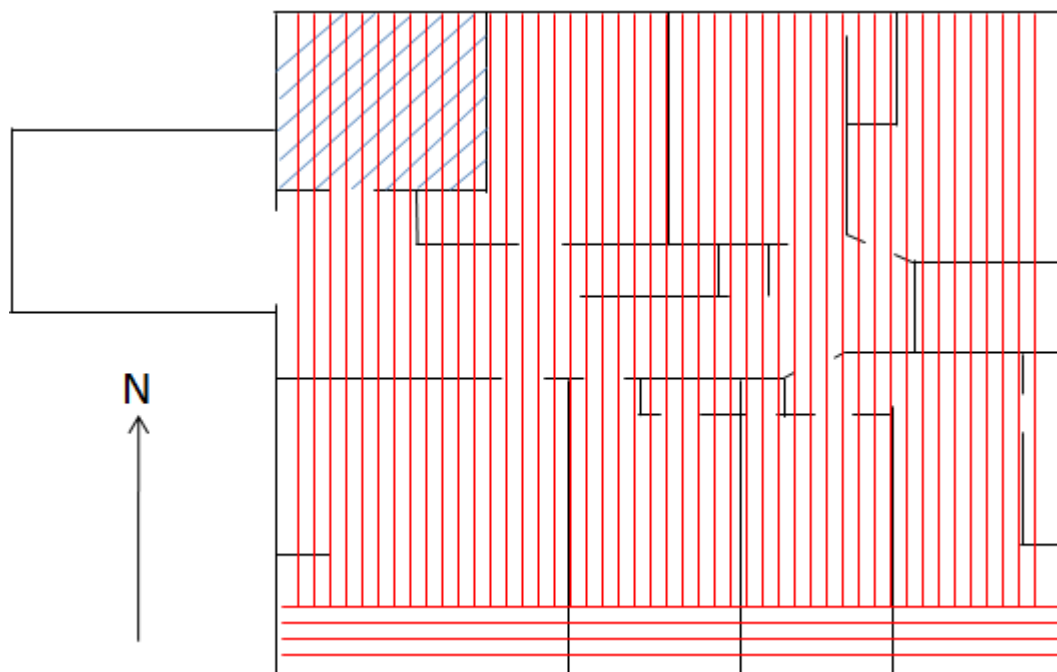
*Schematic representation of third floor framing. The red lines are the general framing of the floor/ceiling joists. The blue lines represent the diagonal layout of the subfloor in that room.*

For the front rooms, the same process used for the rear rooms was used for the rear part of the room. Two to three top floorboards and one to two subfloor boards were removed to expose the underlying joist bay. However, this bay only extended for part of the room. In order to insulate the front part of the room, most (rather than two or three) of the top floor boards had to be removed as the joists ran parallel to the top floors. In order to access the joist bays, one 3ö hole was cut for each joist bay. The location of the joist bays could be easily determined by reading the nail pattern of the sub floor boards so that a minimum number of holes needed to be cut. In the smaller rooms, the floor boards ran the full width of the room and thus were fully removed. In the larger rooms, the floor boards were end joined so that the smaller board in each run could be removed to access the full length of the bay.
