**HISTORIC
NEW ENGLAND**

Lyman House Weatherization Project: Interior Storm Windows

A Component of Energy Retrofit project supported by Massachusetts Department of Energy Resources

Work completed June 2011-February 2012

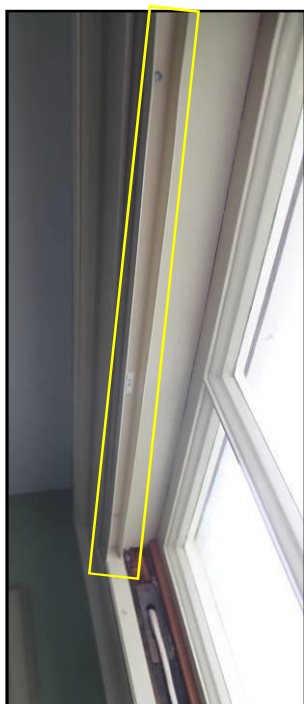
The typical installation involves the securing of a U channel at the top of the window opening. This U-channel is secured with two #8 wood screws. The storm window is then inserted into the opening by compressing its sides and sliding the unit into the U-channel. The storm window unit has a silicone gasket at the top and bottom and a fiber gasket along the side spring loaded compression jambs. Once the unit is installed in the opening, two rivet pins are inserted about 1/3 of the way up the unit to provide final security. These pins require the drilling of two 3/32ø holes.

*Left:
Installation of
U-channel at
top of window
casing*

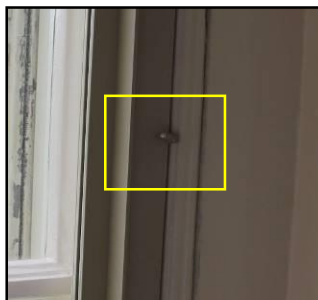
*Above: Rivet pin installed to
help secure side of storm
window*

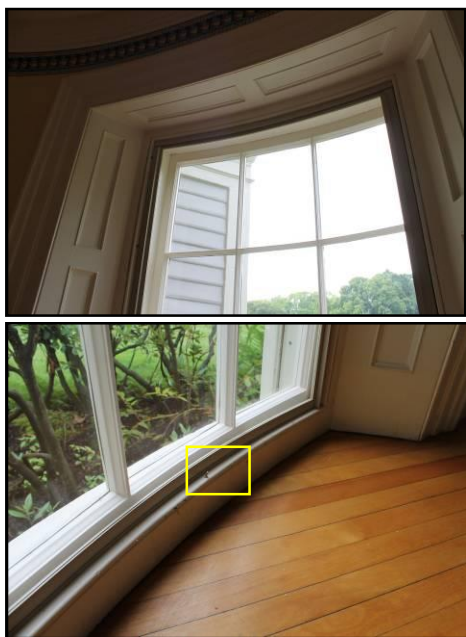
The installation for the Bow Parlor and Oval Chamber required that the units curve to accommodate the opening. This can only be accomplished with the use of UV Plexiglas[®]. For these curved openings, the U-channel at the top was molded to follow the curve of the opening. These openings also require the use of a third pin, located at the bottom sash stop. This pin serves to hold the curve at the bottom of the unit. Note that each of the 5 openings was found to have a different radius. This is likely attributed to the hand construction of this room as part of the 1793 construction period.

Left: curved U-channel to fit curve of opening

Above: additional rivet pin at bottom to hold curve of storm window

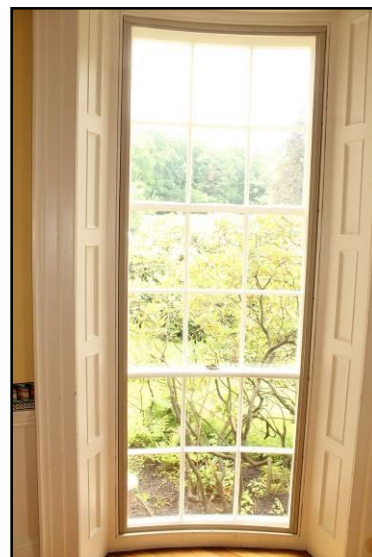
Above: Curved opening in Bow Parlor

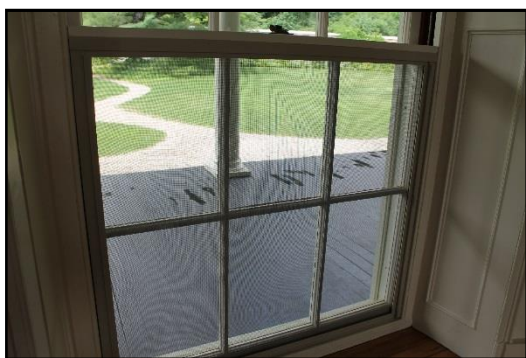
Above: screen insert installed in ballroom

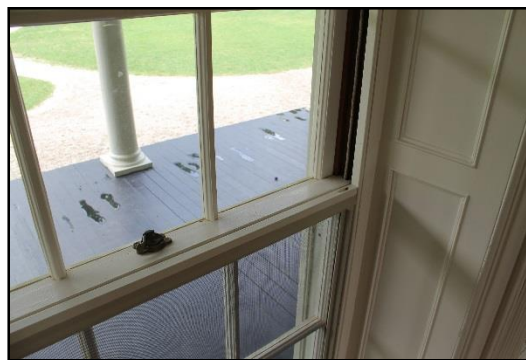
These intermediate rails have been installed so as to minimize impact on the window stops. The rail location was aligned with two sash stop screw locations. A brass threaded insert replaced each of the existing screws. The intermediate rail was then screwed into these inserts with the use of pocket screws. The use of a threaded insert will allow the intermediate rail to be removed and reinstalled repeatedly without gradually stripping out and deteriorating the sash stop.

Above: Added support rail for screen / lower storm in ballroom

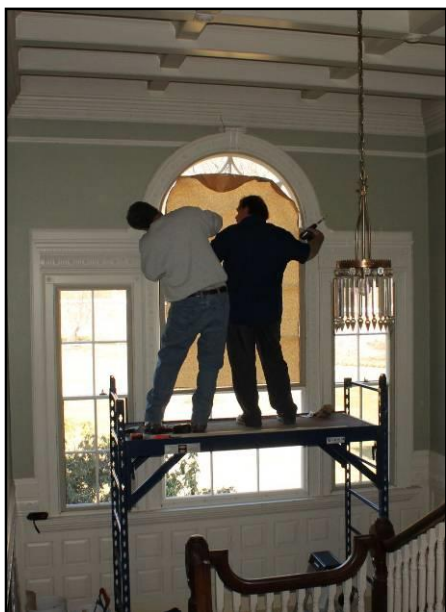
In order to establish the curve at the top of the Palladian window, a pattern was created. In the shop, a piece of curved wooden molding was fashioned to match the pattern. A piece of UV Plexiglas® was then cut to fit into this molding profile. The top section of the Palladian window has been screwed into the jambs to prevent the falling of this component. The bottom section is easily removable and installed in the same manner as the other interior storm windows.

Installation of Palladian storm window

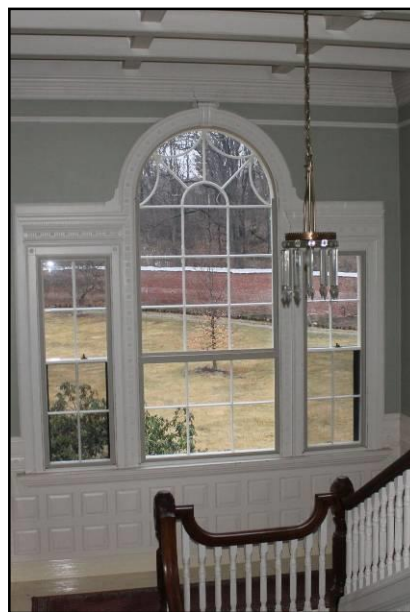
Palladian storm window installed

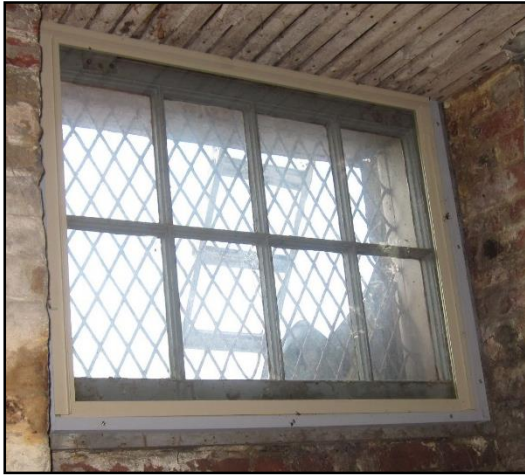
Interior storm windows were also installed in the basement openings where windows were currently installed. Some openings had previously been blocked up over the years and had no windows. These openings were left blocked. As the basement windows were mounted flush with the basement walls, a wooden frame had to be built to hold the storm window. These frames were fabricated on site from poplar and painted grey to match the existing grey sash. The new storm window units were then secured to these frames. This installation process allows can be easily reversed by simply unscrewing the storm window frames.

*Basement window installation
of storm window sash.*

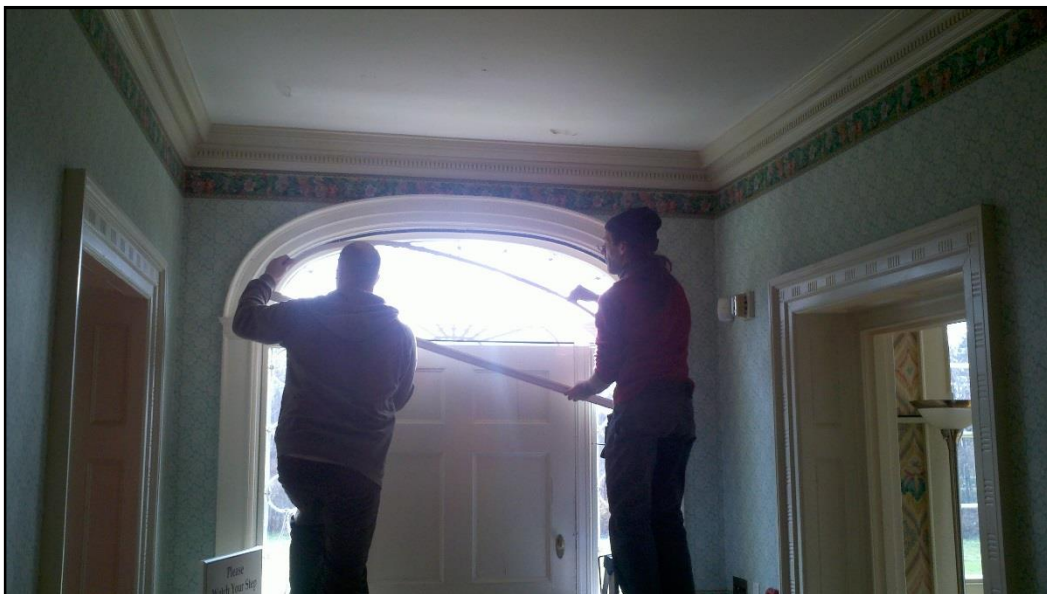
Interior storm windows were also installed at the front entry for the fan light and the side lights. For this application, the storm window solution from Allied was used. This decision was based on the size of these openings, the desire for as thin of a profile as available, and the need for a tempered glass solution to meet code requirements. For this instance, aluminum L brackets were installed with a minimum of screw penetrations to the surrounding window frames. This aluminum L bracket is faced with a magnetic strip that interfaces with the magnetic strip on the edges of the storm window. While this magnet creates a positive seal, two screws per unit provide additional security as vibrations from the repeated door closing may loosen the seal. In this case, the default cream color of the Allied product provides a near match to the existing paint treatment.

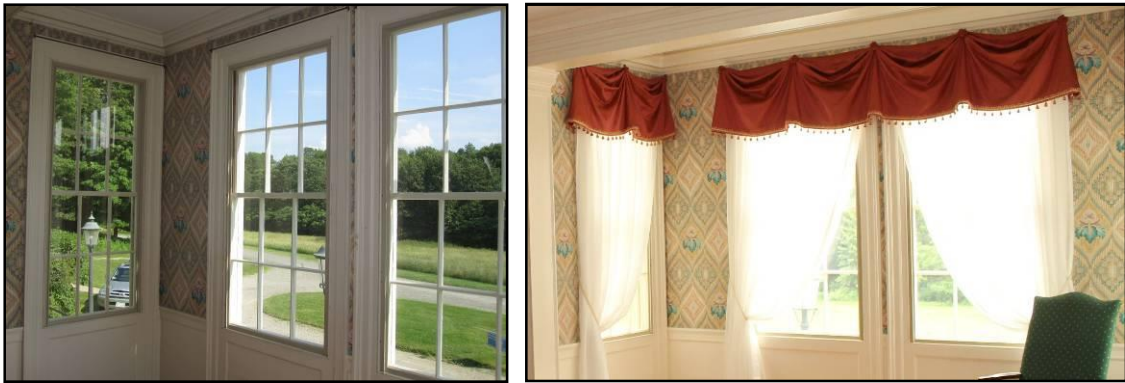
The key issue with the interior storm windows is that the color for the frames was not matched to the paint color of the interior. An alternative product could have been selected that would have been color matched, but the expense of that would have resulted in cuts in other energy efficient strategies. As most windows have (or will have) interior textile treatments this color difference is somewhat minimized.

Interior storm windows installed

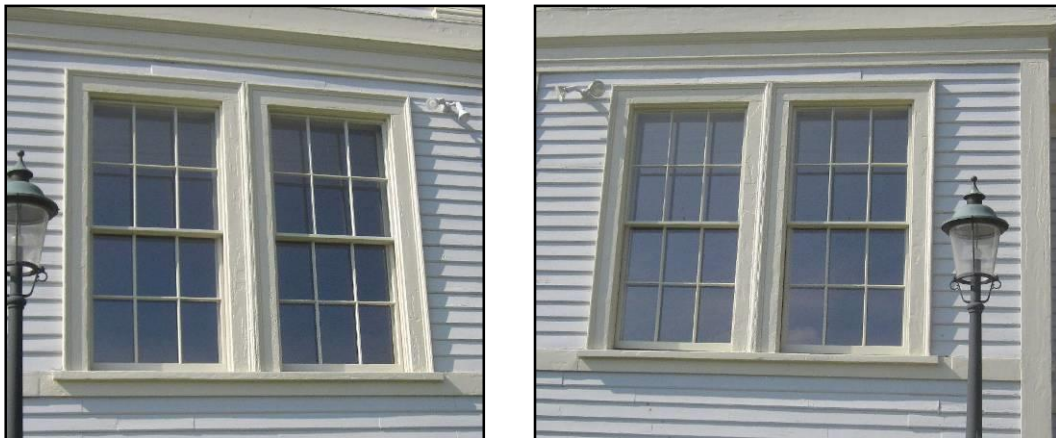
It should also be noted that while the interior storm windows are invisible when viewed from the exterior, they do have a reflective component such that when viewed closely one can see the reflection of the muntins. One would have to be very sensitive to this detail to truly observe it, but it is there.

*Interior storm windows installed
Note muntin reflection in top sash*

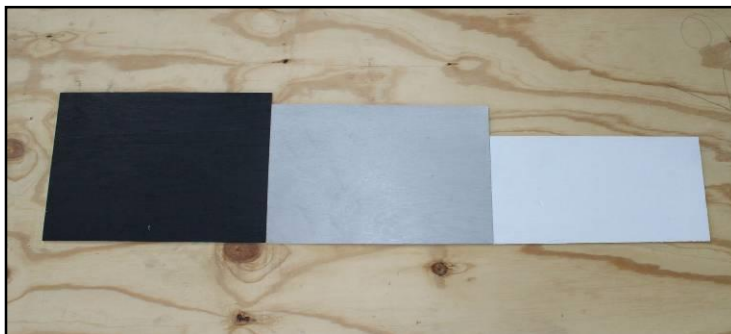
After installation of the storm windows, various blower door tests were performed on rooms with the storm windows. These rooms are the East Parlor, Dining Room, and Brideø Room. Infiltration measurements found that there was an overall decrease in infiltration by 30% in each room tested. With the storm windows uninstalled, approximately 10% of the reduction could be attributed to the sash conservation and weatherization efforts.

Relative affect on air infiltration of sash conservation/weatherization and implementation of interior storm windows.

- *Black represents net room "opening" before intervention*
- *Grey represents sash conservation / weatherization contribution (~10%)*
- *White represents net opening after interior storm window installation. (additional 20%)*

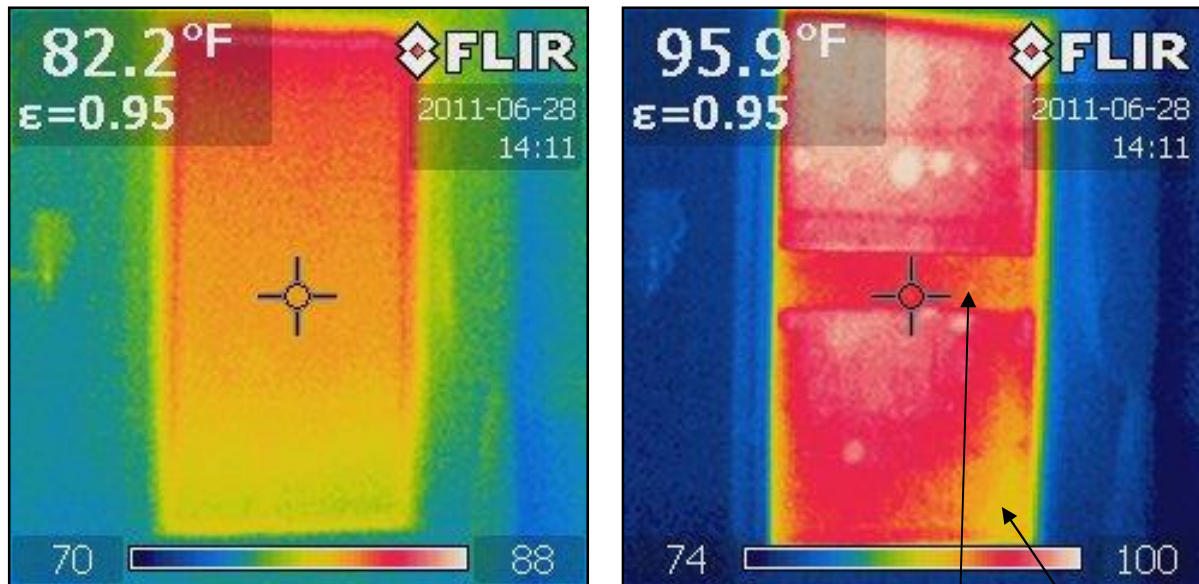
*With interior storm
Exterior heat is largely
blocked from the interior*

*Without interior storm
Significant exterior heat is
allowed to pass through to
the interior space*

*Conditions:
Window 2-06
West facing window
Black ½" plywood blank insert
Exterior temp: 81
Partly sunny*
