Case Study in Exterior Storm Windows

Lyman House Weatherization Project: Exterior Storm Windows

A Component of Energy Retrofit project supported by Massachusetts Department of Energy Resources

Work completed August 2011-December 2011

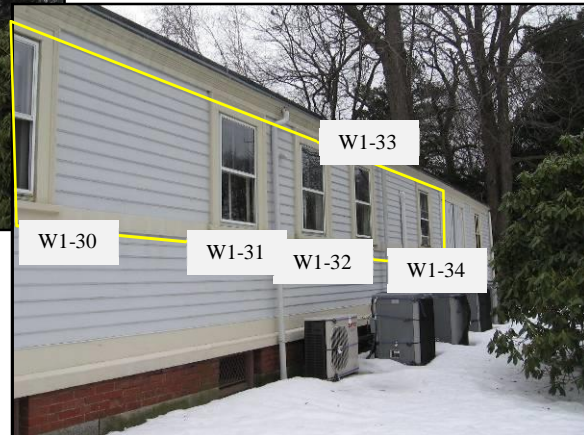
*North elevation, 2nd floor office windows
and 1st floor kitchen and service wing*

Historic New England's experience with exterior storm windows has been limited over the years, although many properties have some form of exterior storm window. Where installed, most appear to be a common, mass-marketed "triple track" storm window of a stock color. These "triple track" storm windows have two glass panels and one screen panel, with each panel sliding independently in its own track to allow varying options for sealing. Some properties have single "dead light" storm panels installed as a seasonal maintenance task; in some cases, only the frames remain as the lights have been damaged or otherwise lost to time. Effectiveness of blocking air infiltration has never been measured and documented.

During the review of interior storm window options, one player was also seen as a quality exterior product providing a low profile option that would minimally impact the visual aesthetic of the property. Allied Window's Historic One Lite with removable bottom pane was selected for the rear facing windows.
