### **Case Study - Insulation**

Lyman House Weatherization Project: Insulation

*A Component of Energy Retrofit project supported by Massachusetts Department of Energy Resources*

Work completed April 2012

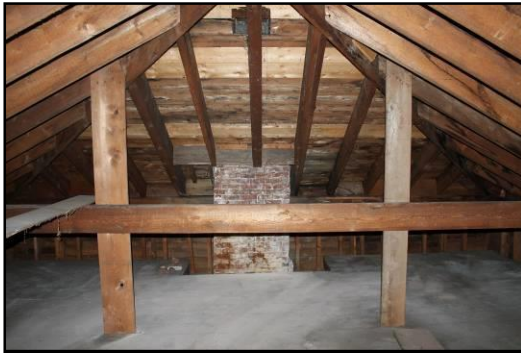
*View over ballroom as seen from catwalk towards chimney at east end.*

Over the ballroom space, it was decided to blanket the ballroom attic floor rather than attempt to fill the void between the ballroom ceiling and attic floor. Accessibility and risk of potential damage in this space was the primary decision driver. As the construction of the ballroom evolved over time with newer exterior walls, there was a series of joist bays along the perimeter. These bays were blocked at the level of the attic floor with the Roxul insulation batts stuffed into the opening. Similarly, the chases alongside of the chimney ran the full height of the building from the basement. These chases were capped off with foam board. Once the floor was sealed at the perimeter, approximately 20' of loose fill cellulose insulation was blanketed on top of the floor. As this makes the ballroom attic floor inaccessible, a tower of foam board was set on top of a removable floor board section. If there is ever a need to access the space above the ballroom ceiling, this "beacon" provides identification of the access location and a path could be cleared to this opening.

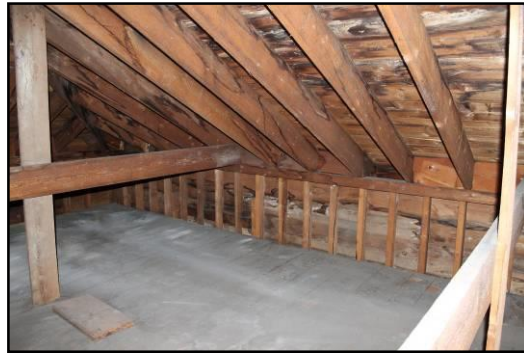
*View over ballroom looking southeast*

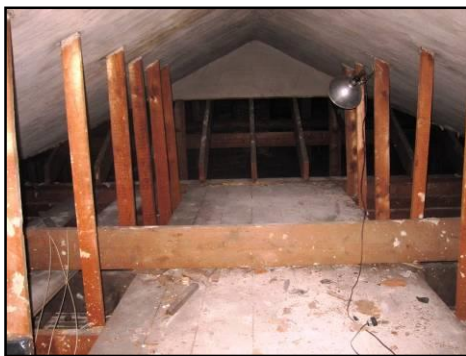
*View of catwalk as seen from entry to ballroom attic space.*

There is a catwalk over the ballroom chamber with the ceiling joist bays exposed on both sides of the catwalk. As these bays were open, the bays were filled with cellulose insulation in a 'loose fill' manner. As such, the insulation was deeper in these cavities in order to provide for the desired R value. To contain the insulation, foam board walls were set along the sides of the catwalk to keep the insulation from covering the catwalk.

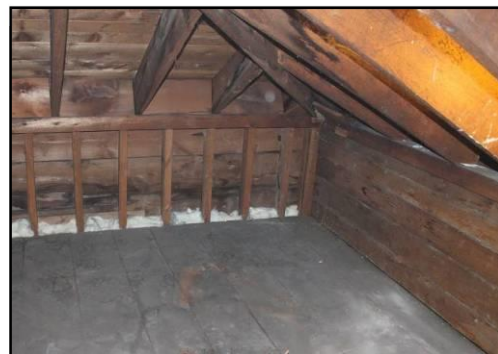
Directly above the ballroom ceiling is a space approximately 31-1/4' high, capped by a floor. This then leaves a wide open space between the floor and roof of approximately 10' in the middle, with diminishing heights commensurate with the hipped roof structure. As the 2<sup>nd</sup> floor ballroom chamber abuts the ballroom attic, there is approximately 33-1/2' of vertical exposure ñ essentially a knee wall.

*South wall of ballroom attic and knee wall at junction with ceiling over ballroom chamber*

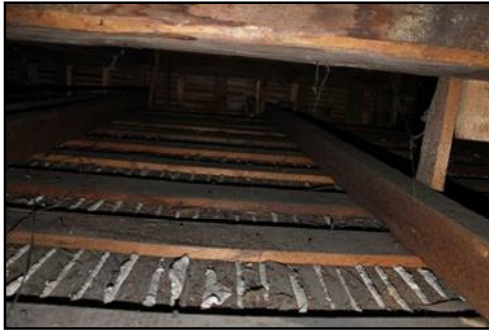
*Space between ballroom ceiling and attic floor*

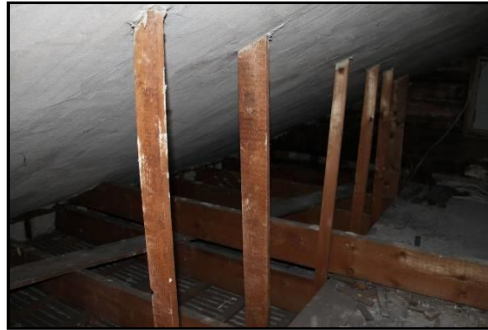
*Catwalk space with open joist bays*
